ACCIDENT

| Aircraft Type and Registration: | Eurocopter EC135T1, VP-CPS | |
| Date & Time (UTC): | 26 February 2019 at 1631 hrs | |
| Location: | Owen Roberts International Airport, Cayman Islands | |

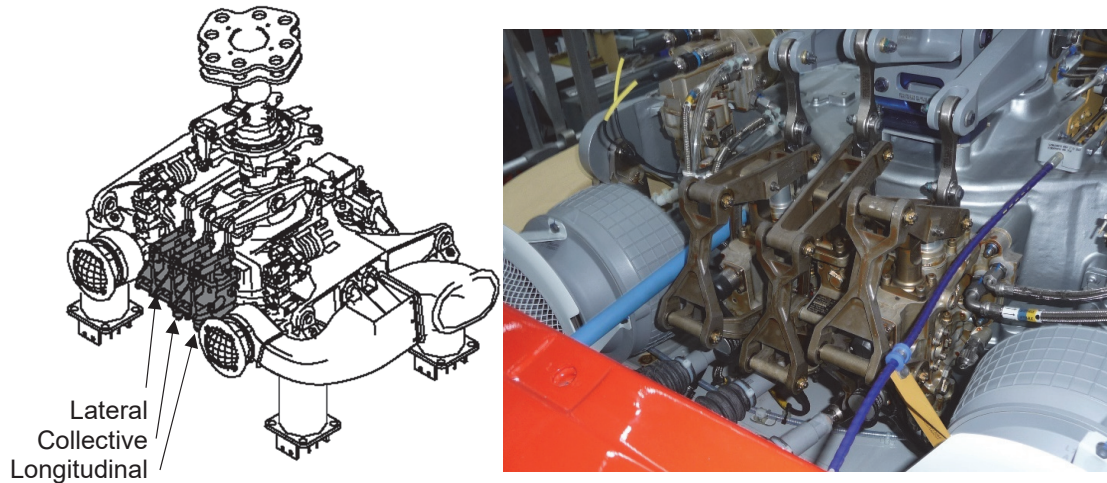
Figure 2

The main rotor swashplate is moved in the lateral, longitudinal and collective axes by three hydraulic actuators and together they comprise the Main Rotor Actuator (MRA). The actuators are located forward of the rotor mast between the engine air intakes (Figure 2) and are all similar in construction.

Typical installation of the MRA (not VP-CPS) - (Airbus)
